PATTERN OF SEED LOSSES AND DAMAGE DURING SOYBEAN HARVEST WITH GRAIN COMBINE HARVESTERS*

J. Kowalczyk

Department of Horticultural Machinery, University of Agriculture, Głęboka 28, 20-612 Lublin, Poland

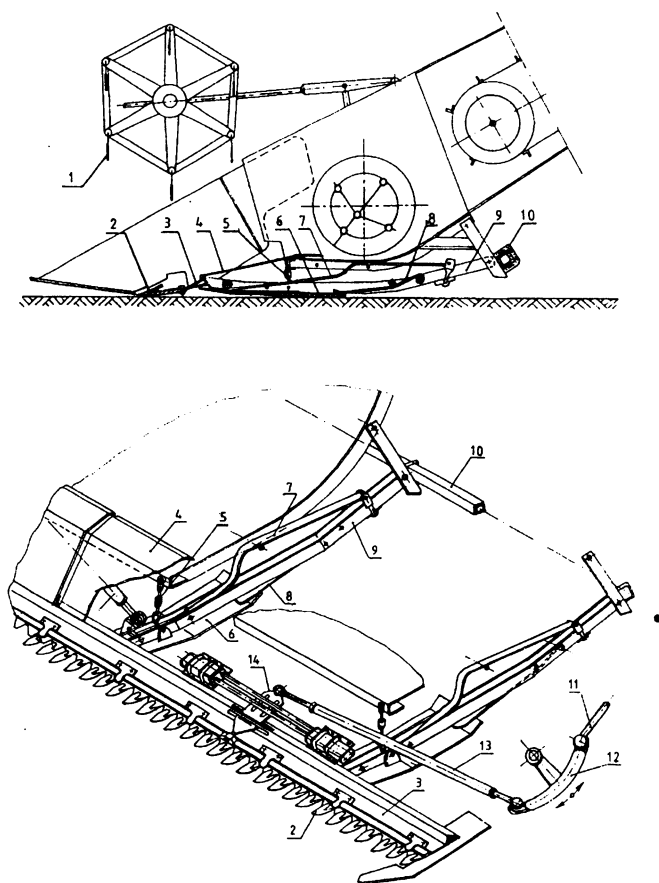
Fig. 1. Schema of the header of the Z056 Bizon-Super grain combine harvester equipped with the tracing cutting assembly: 1-rubber belt, 2-cutter bar finger, 3-finger bar, 4-shield, 5-chain, 6-skid, 7-lightening spring, 8-pressure spring, 9-carrying beam, 10-suspension beam, 11-pitman, 12-angle lever, 13-cross rod, 14-lever with a slide.

The main objective of the investigations was to determine the seed loss and seed damage that occur during harvest of soybean with the Z056 Bizon-Super grain combine harvester equipped with the tracing and with the standard cutting assemblies. The schema of the tracing cutting assembly with the mechanically driven cutterbar is presented in Fig. 1. The assembly makes it possible to go down

with the cutting height as low as 3 cm due to its tracing capability with regard to the irregularities in the field surface.

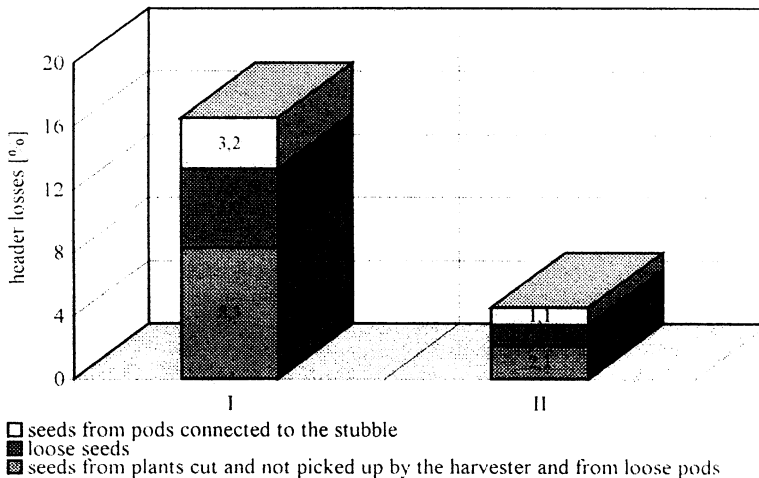
Fig. 2. The structure of soybean seed losses caused by the headers under investigation: I-Z056 Bizon-Super combine harvester header equipped with the standard cutting assembly, II-header of the Z056 Bizon-Super combine harvester equipped with the tracing cutting assembly.

The results of the investigations are given in Tables 1, 2 and Fig. 2.

The biggest losses caused by the header were seeds in pods connected to the stubble (Fig. 2). They averaged 2.1% for the tracing cutting assembly and 8.3% for the standard cutting assembly.
